Manhole Inspection Summary

Manhole # S13EE1023MH

Location Address: **4140 REISTERSTOWN RD** Cross Street: **QUANTCO AVE**

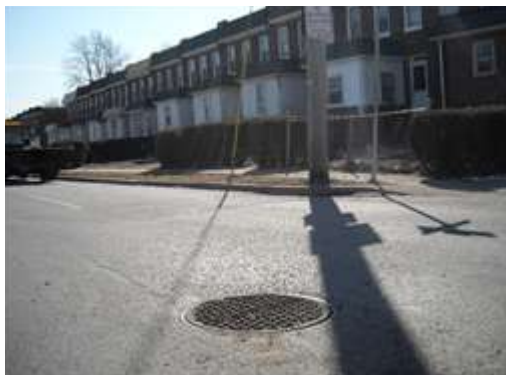
NEW LID IS ON MH

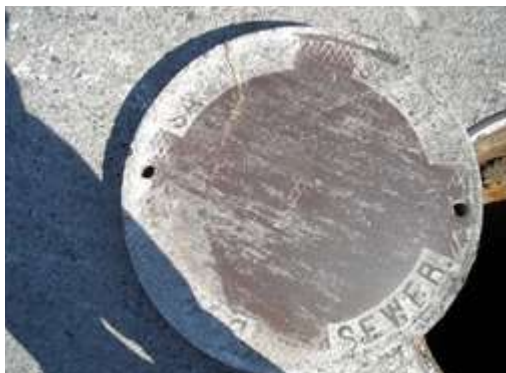
PREVIOUS LID WAS WORN AND CRACKED

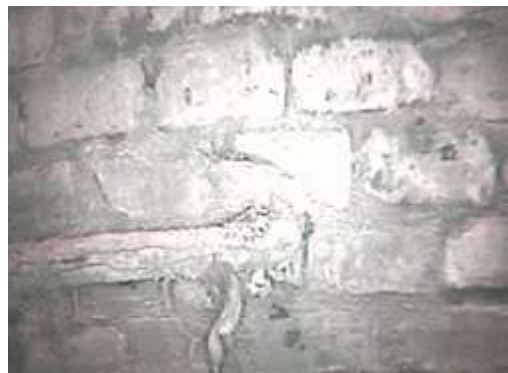
Defect 8

Surcharge ☒ Evidence Of Surcharge Depth: **3** (ft.) ☐ Active Surcharge Present

EVIDENCE OF SURCHARGE AT 3 FEET, ON A CORRODED STEP

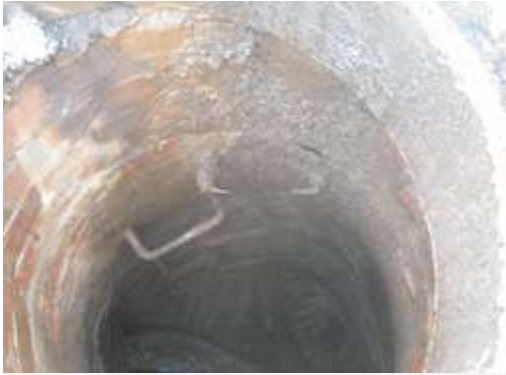
Defect 2

Steps Count: **4** Missing: **1** ☒ Corroded

MISSING STEP

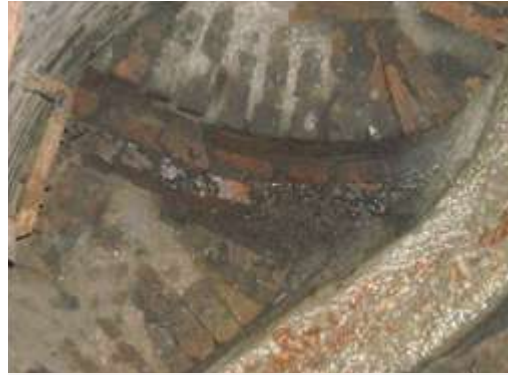
Defect 3

Bench ☒ Exists Material: **Brick** ☐ Parged
Condition: ☐ Sound ☒ Cracked ☐ Root Intrusion ☒ Deteriorated ☐ Leaks ☐ Debris

BENCH HAS DEGRADED AND IS MISSING SEVERAL BRICKS

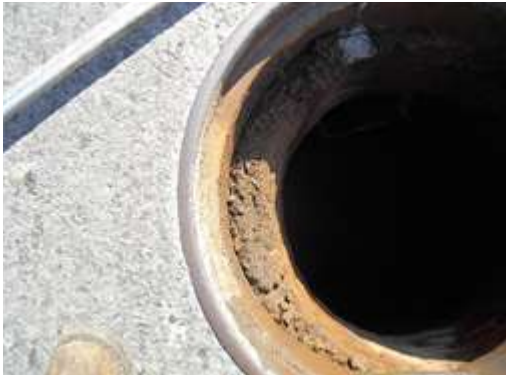
Defect 1

Frame Offset: **3** (in.) Condition: ☒ Sound ☐ Cracked ☐ Leaks

FRAME OFFSET 3" AND EVIDENCE OF INFLOW DUE TO SHEETING

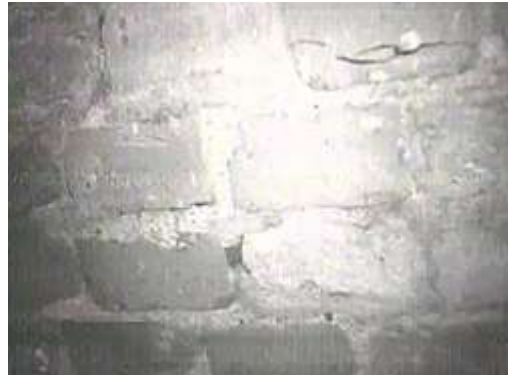
Defect 7

Corbel Material: **Brick** ☐ Parged Type: **Concentric/Eccentric**
Condition: ☒ Sound ☐ Cracked ☐ Root Intrusion ☐ Loose Brick ☐ Deteriorated
Infiltration: ☐ None ☐ Joint ☒ Cracks ☒ Mortar ☐ Roots ☐ Wall

CRACKED BRICK AND MISSING MORTAR IN CORBEL WALL

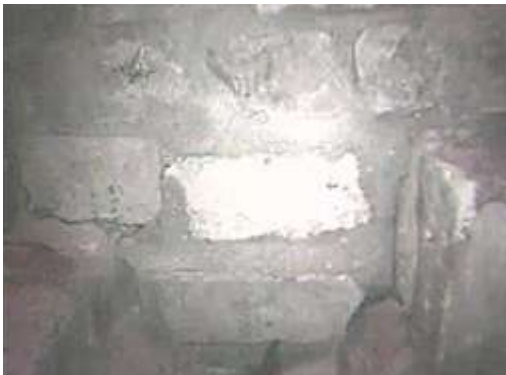
Defect 6

CAPPED PIPE CONNECTION AT 6 OCLOCK

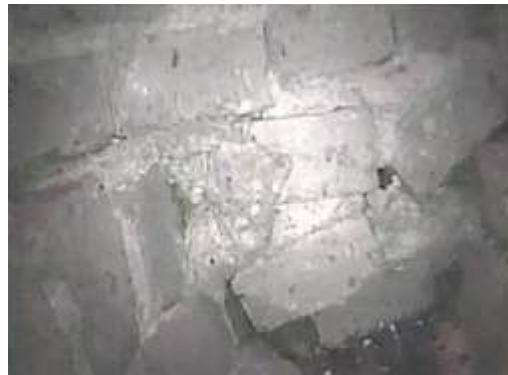
Defect 5

CAPPED PIPE CONNECTION AT 4 OCLOCK

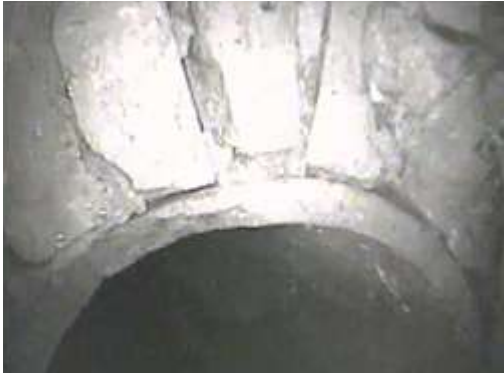
Defect 4

MISSING MORTAR ABOVE 12 OCLOCK
PIPE CONNECTION

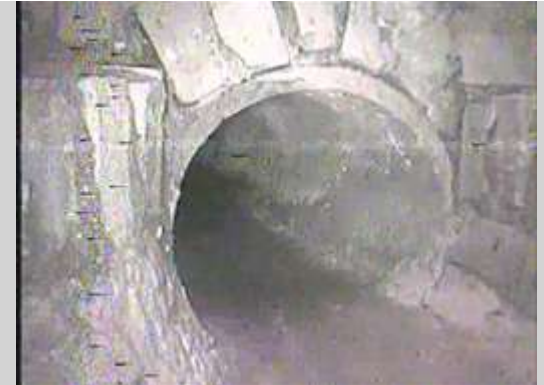
12 O'Clock Outflow

NOTE MISSING MORTAR AROUND SEAL

Pipe Height: **10.8** (in.) Rod and Bar (Angled)
Pipe Material: **Clay** ☐ Pipe Lined
Invert Depth: **10.10** (ft.) Flow Characteristics: **Slow**
Deposits: ☒ None ☐ Mud ☐ Sludge ☐ Debris ☐ Grease
Silt Depth: (in.) Deposits Extent:
Infiltration: **None** Pipe Seal Cond: **Cracked**

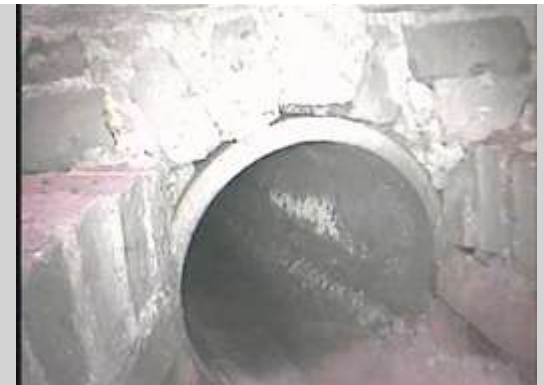
6 O'Clock Inflow

NOTE MISSING MORTAR AROUND SEAL

Pipe Height: **10.8** (in.) Rod and Bar (Angled)
Pipe Material: **Clay** ☐ Pipe Lined
Invert Depth: **9.81** (ft.) Flow Characteristics: **None**
Deposits: ☒ None ☐ Mud ☐ Sludge ☐ Debris ☐ Grease
Silt Depth: (in.) Deposits Extent:
Infiltration: **None** Pipe Seal Cond: **Cracked**
